State of Utah
DEPARTMENT OF NATURAL RESOURCES
Division of Oil, Gas & Mining

Inspection Report
Minerals Regulatory Program
January 31, 2013

Mine Name: Morgan Facility	Permit Number: M/029/0008
Operator Name: Geneva Rock Products, Inc.	Inspection Date: November 13, 2010
Inspector(s): L Heppler	Time: 2:00 PM
Other Participants: none	Mine Status: Active

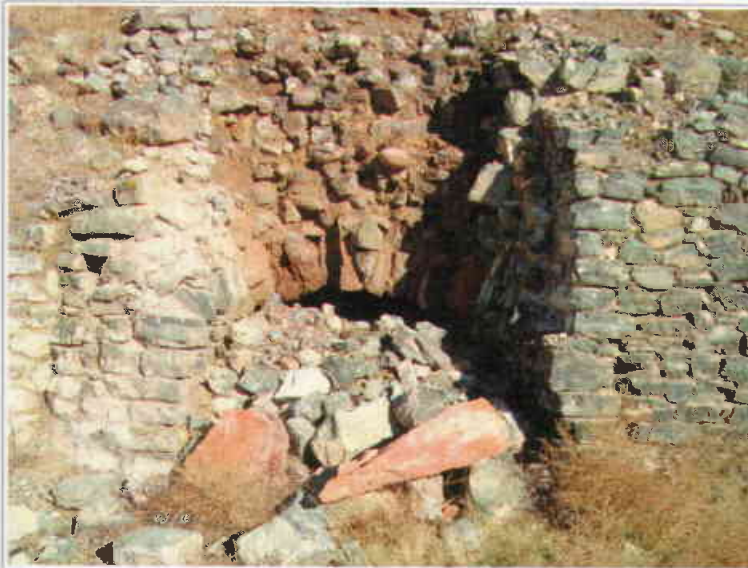
Historic Kiln

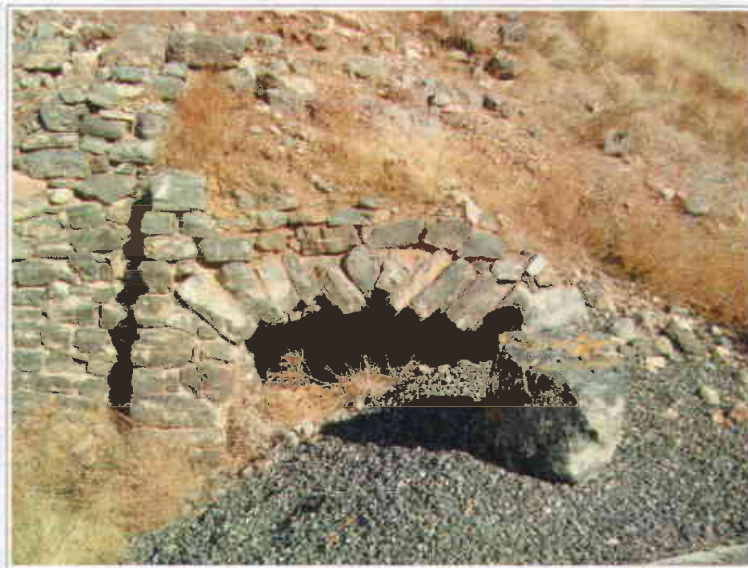
Historic Kiln

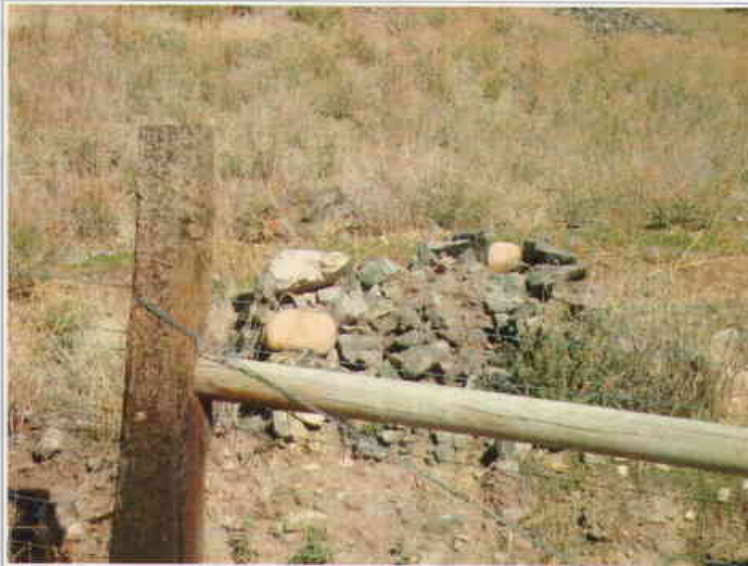
Historic monument

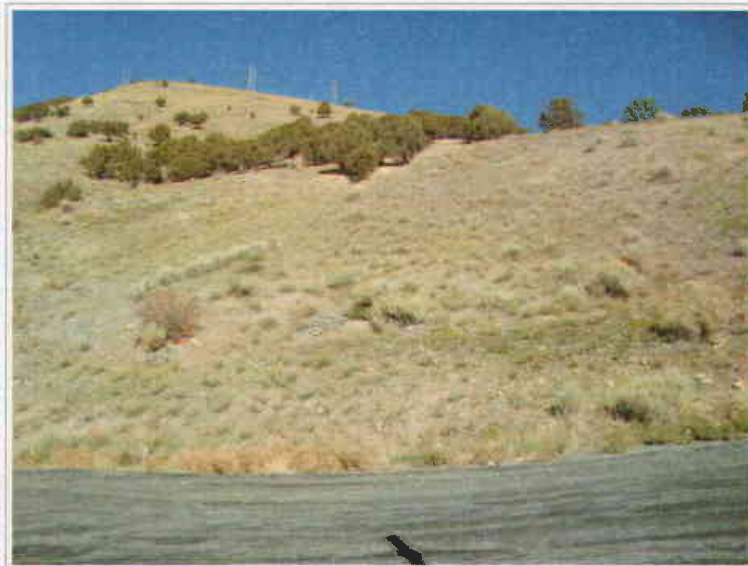
Natural hillside prior to mining

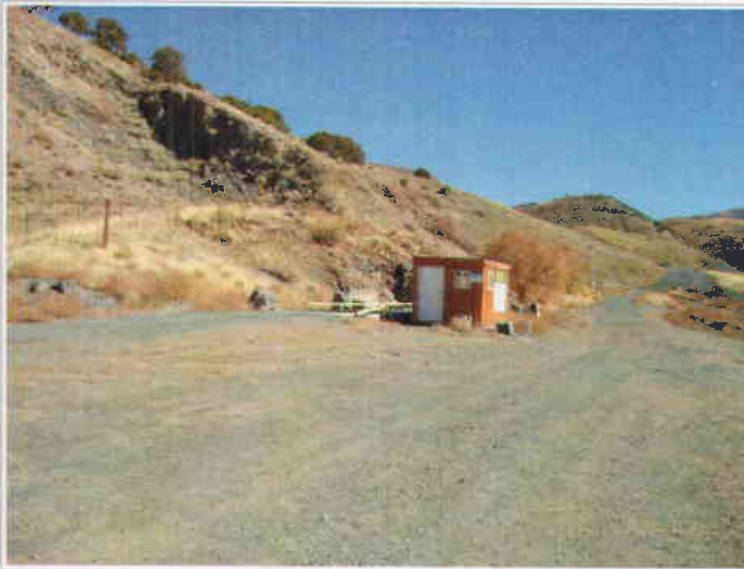
Scale house

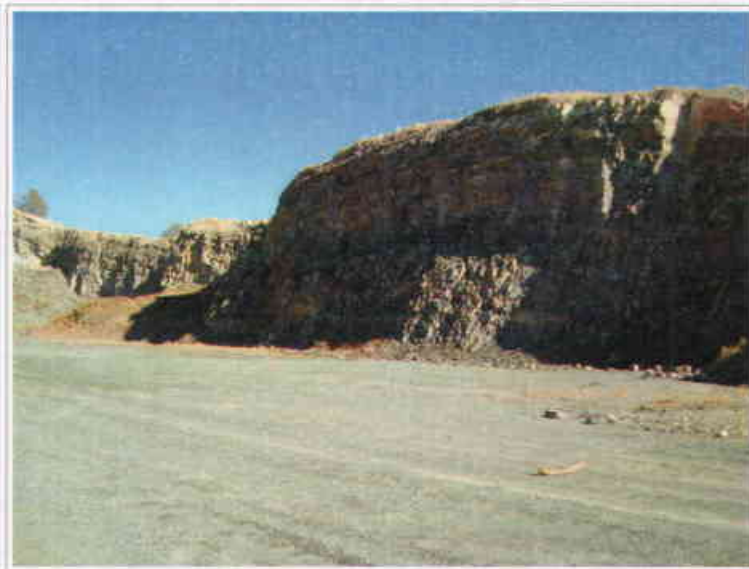
Upper pit with highwall

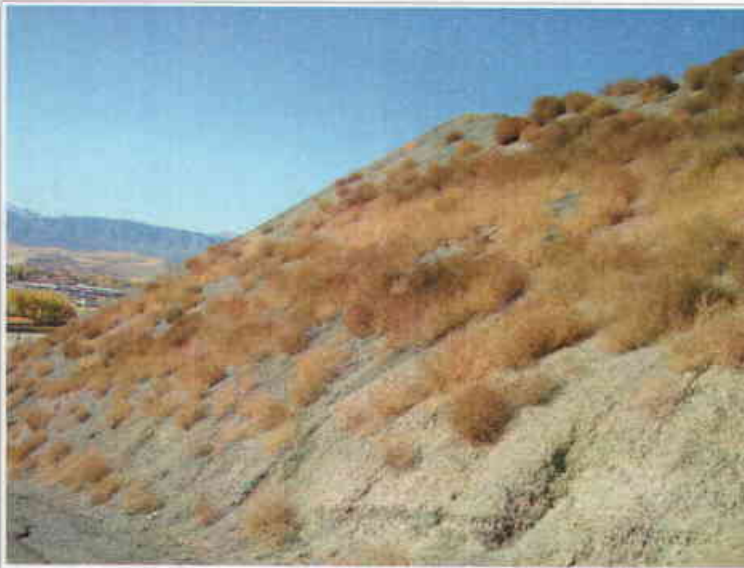
Lower slope with Russian Thistle

Conclusions and Recommendations: The Operator will have difficulty with revegetation, due to lack of topsoil from the 2 prior small mining operations, but with proper planning in the future revegetation is still possible. The Operator should start developing a growth medium stockpile. OGM to continue annual inspections and monitor the site when in the area.

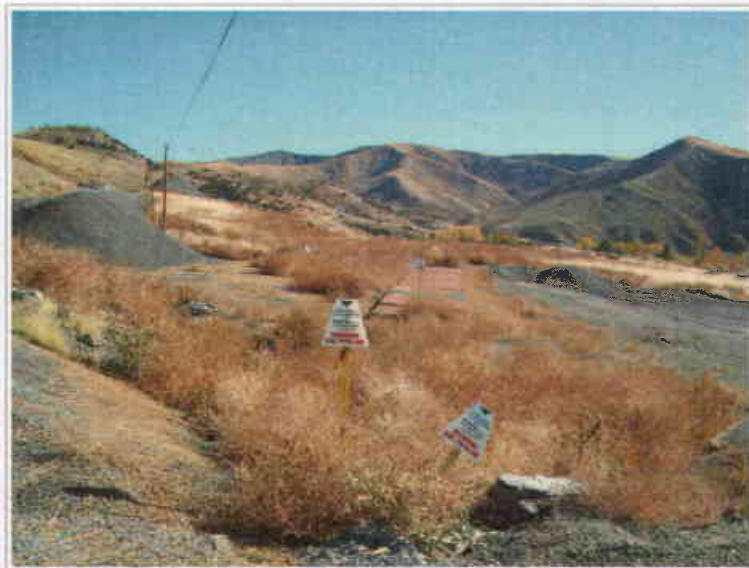
High pressure gas line
